# SOUTHEAST ASIA ACTIVITY REPORT

# SELECTED TRANSPORTATION AND INFILTRATION COMPENDIUM

NPIC/R-252/67 NOVEMBER 1967

SUMMARY NO. 63

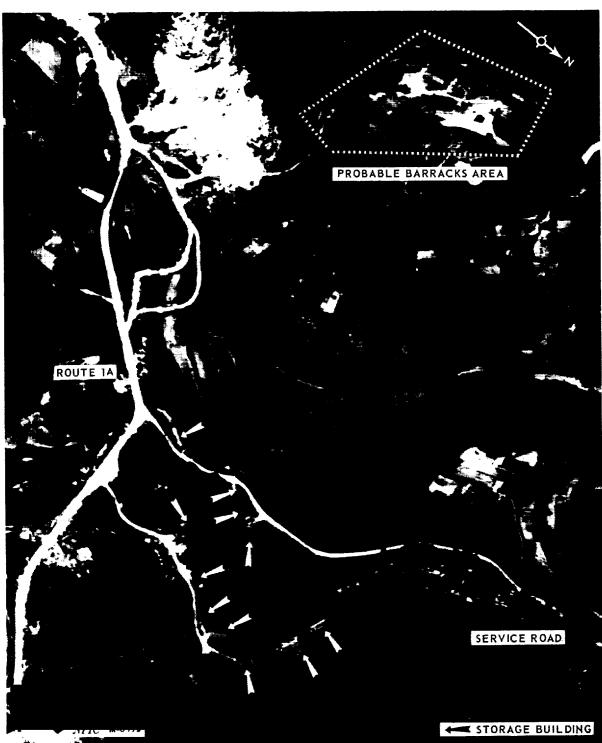
FIGURE 1. MAI SAO HA (2) MILITARY AREA, NORTH VIETNAM

24 buildings and at least 14 trucks (Figure 2)
9 probable barracks and 3 support buildings (Figure 2)
8 buildings, at least 20 vehicle slots and 3 vehicles
11 storage buildings and an open storage area (Figure 1)
9 probable barracks and 6 support buildings (Figure 1)

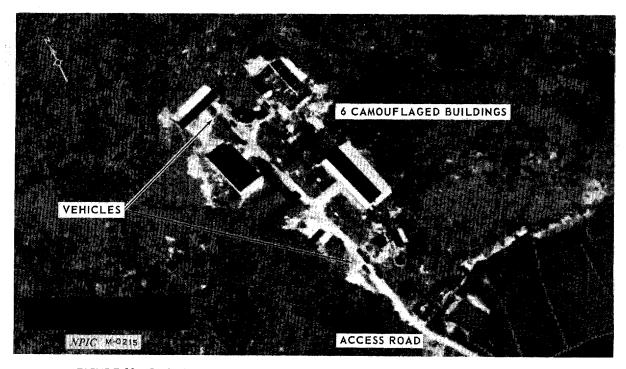
FIGURE 12. PROBABLE STORAGE FACILITY, TRAI SON AREA, NORTH VIETNAM

```
1. 25X1D
2. 25X1D
3. 25X1D
4. 9 buildings (2 camouflaged) and 5)
5. 7 camouflaged buildings and 25X1D
6. 6 camouflaged buildings and 22 vehicles (Figure 12)
7. 1 road-served building in a small canyon (Figure 13)
```

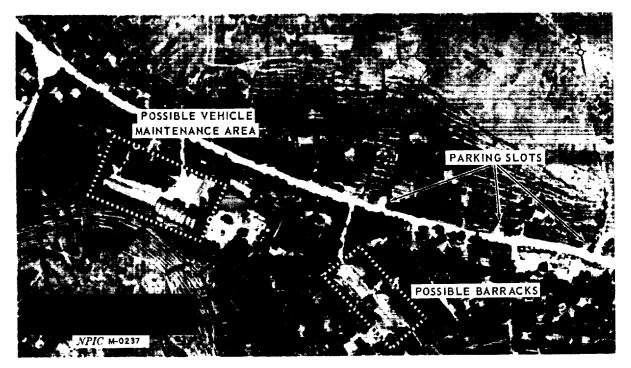
FIGURE 14. VEHICLE SUPPORT FACILITIES, HA NOI AREA, NORTH VIETNAM

Numerous vehicle parking and possible support facilities are dispersed within an area of concentrated villages approximately 9nm northeast of Ha Noi. Such utilization of villages for the partial concealment/protection of vehicular activity is becoming increasingly prevalent in North Vietnam (see Summary 55, Item 2). The area within a 1.5-nm radius of UTM 25X1D -- included as an example of this activity -- contained the following on 19 trucks, 10 probable trucks, 5 possible trucks, 79 vehicle parking slots (many revetted), 10 probable vehicle shelters, 2 probable and at least 27 support buildings. vehicle bunkers,

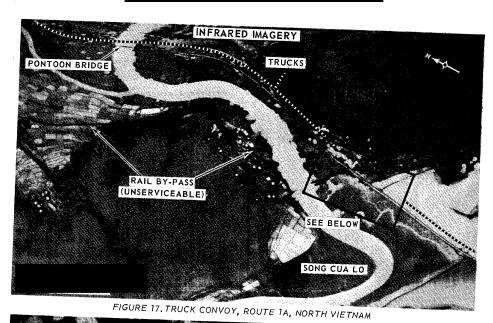
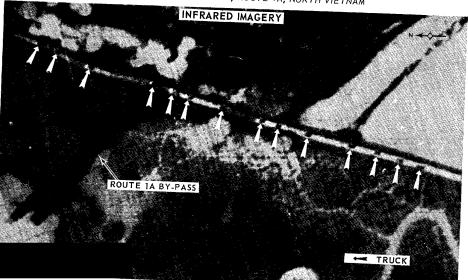
FIGURE 18.TRUCK CONVOY, ROUTE 1A, NORTH VIETNAM

```
Night infrared imagery of
                                                                revealed the largest con-
           centration of vehicles identified in the North Vietnam panhandle since the 1967 Tet Truce (Figures 17 and 18). A northbound convoy of approximately
 25X1D
           100 trucks was located 11 nm north of Vinh on route 1A between 18-49-10
                                                                                            25X1D
25X1D
           105-39-E (UTM
                                   ) and 18-51 N 105-39-
                                                                                            25X1D
25X1D
                                                                              Light-dark
           spot returns indicate that four southbound trucks were also in the area.
25X1D
25X1D
                The convoy crossed the Song Cau Lo (river) on a pontoon bridge at

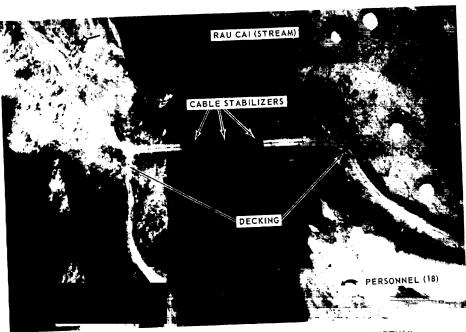
FIGURE 19. TREADWAY CABLE BRIDGE, ROUTE 1502, NORTH VIETNAM

25X1D 25X1D A treadway-type cable bridge, utilizing parallel dual tracks, is identified on Route 1502, 1 nn west of Xom Ca Trang at 17-57 10 N 105-48 15 (UTM 105-48 16 Personnel were observed emplacing half-width decking on the cables (Figure 19). These smaller lengths of decking are lighter and therefore easier to handle than the usual full-width decking. Three cross-supports are in place to stabilize the six cables.

The flexible nature of this type of cable bridge is demonstrated on photography of where all decking and all but one of the cross-supports have been removed to provide the deceptive appearance of unserviceability.

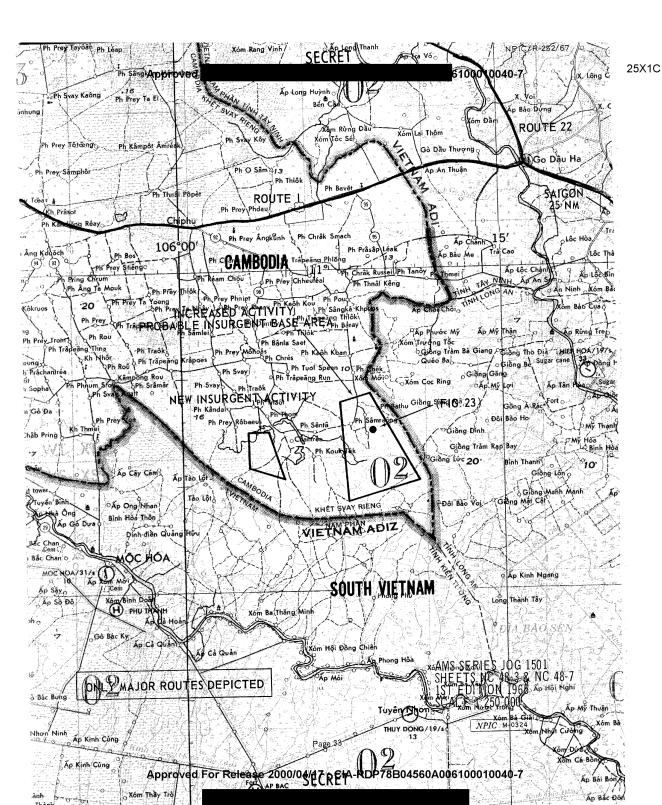
FIGURE 23 PROBABLE INSURGENT BASE AREA, SVAY RIENG PROVINCE, CAMBODIA

A higher level of probable insurgent activity is observed in Svay 25X1D Rieng Province, Cambodia, near the South Vietnam border. The nature of the activity was first identified on of this year (Summary 46, Item 5) and was subsequently reported as increasing in (Summaries 50, Item 4 and 55, Item 7).

(Figure 23)
